SUBJ: FMS and GPS Equipment Advisory Vertical Guidance with no
Published Vertical Descent Angle

SAIB: HQ-14-25
Date: August 26, 2014

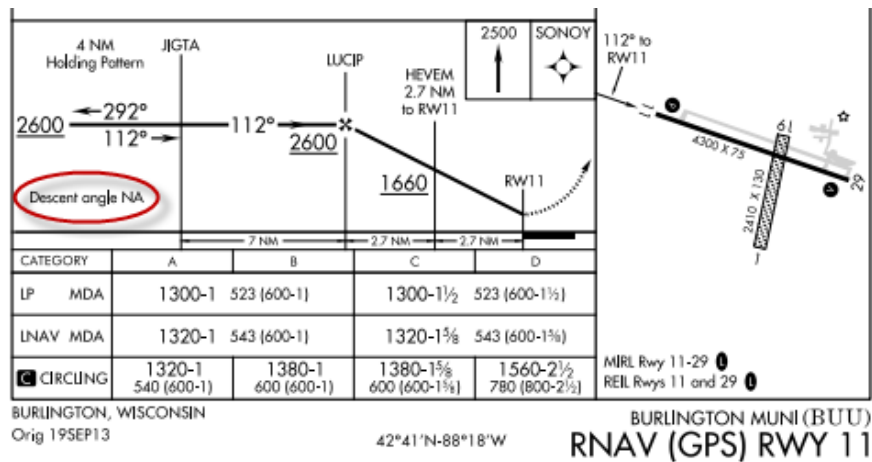
When the FAA charts these IAPs, they do not show a vertical descent angle in the profile view.

The charts currently include the following statement: “**Descent Angle NA**”. Like flying any other IAP, the pilot must see and avoid any obstacles in the visual segment during transition to landing.
