ARINC 424 NDB

**Draft 3 of Supplement 21
Discussion**

ZERO AS VDA

SUBJ: FMS and GPS Equipment Advisory Vertical Guidance with no
Published Vertical Descent Angle

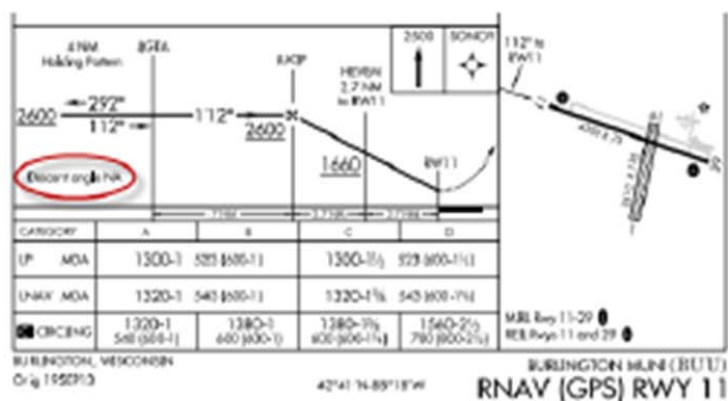
When the FAA charts these IAPs, they do not show a vertical descent angle in the profile view.

The charts currently include the following statement: **“Descent Angle NA”**. Like flying any other IAP, the pilot must see and avoid any obstacles in the visual segment during transition to landing.

The affected IAPs may create a hazard if the pilot continued to reference the advisory vertical guidance while transitioning to the visual segment of the approach. To avoid creating a possible hazard, FAA procedure designers began excluding a vertical descent angle from these IAPs and coding a “0” (zero) in the appropriate ARINC 424 database format specifications to communicate the absence of the vertical descent angle.
