2017 MMC Program

Mechanical Maintenance Conference

An ARINC Document
Prepared by AMC
Published by SAE ITC
16701 Melford Blvd., Suite 120
Bowie, Maryland, 20715 USA

AMC Reference 17-110/MSG-338
August 31, 2017

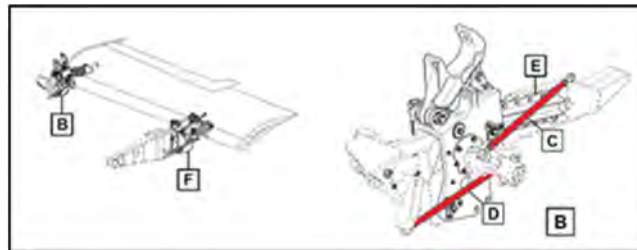
Figure 1: Typical Installation

JAL (J-Air) experienced both IB OB Flap Rod Assy Bend/Broken. To avoid delay/cancellation, we performed the repeat inspection by 120 FH (2+ weeks!).

It seems the inspection works fine. We know that these components have a function as a mechanical fuse. For each defect, we are checking the condition which gives excessive load to the wing. But for now, there is nothing like hard landing, or hard turbulence.

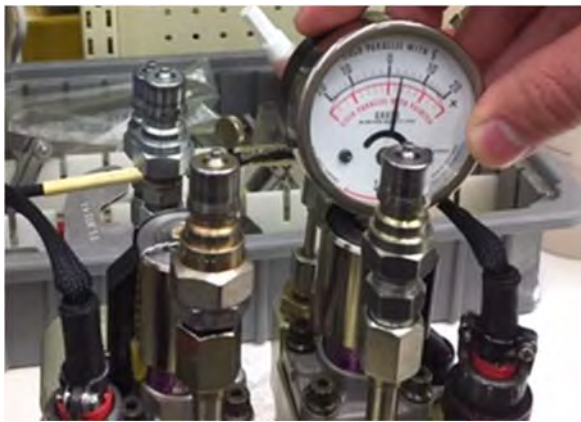
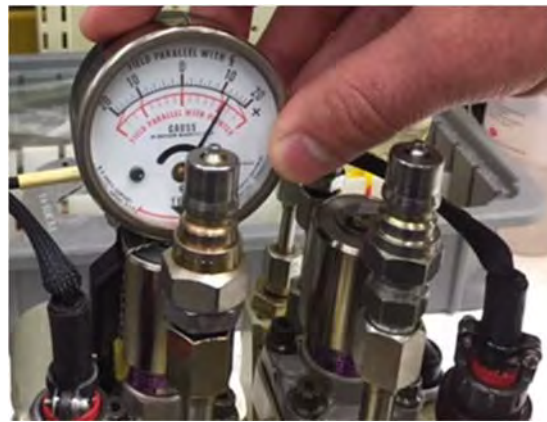
B737-900ER Elevator Feel Computer (MOOG P/N CA27977-001/-003) continues to cause operational disruptions due to reliability. The -003 has been an improvement however UAL continues to see failures. -003 failures seem to result more from failed solenoids than from other failure modes.

UAL would like to share troubleshooting techniques developed with Moog to identify failed solenoids on-wing and would like to request that Boeing make the solenoids an LRU (similar to the 757-300 elevator feel computer).

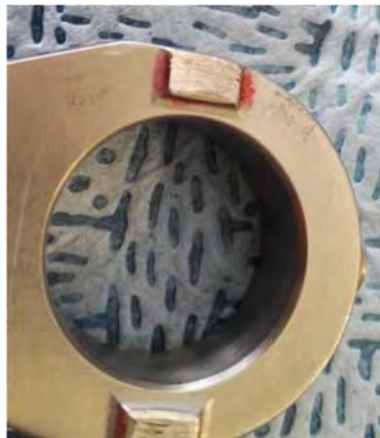
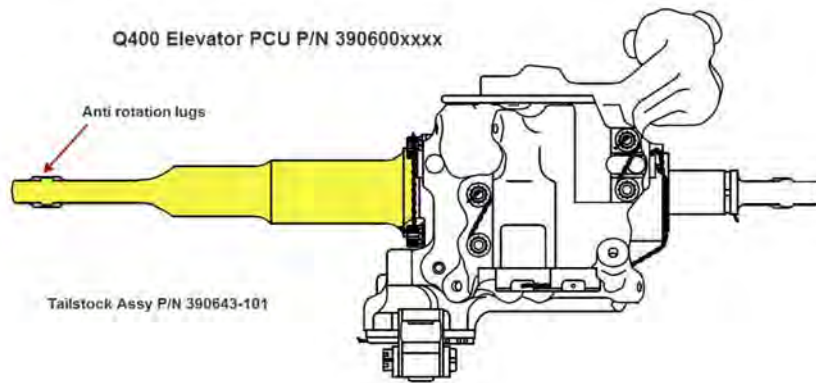
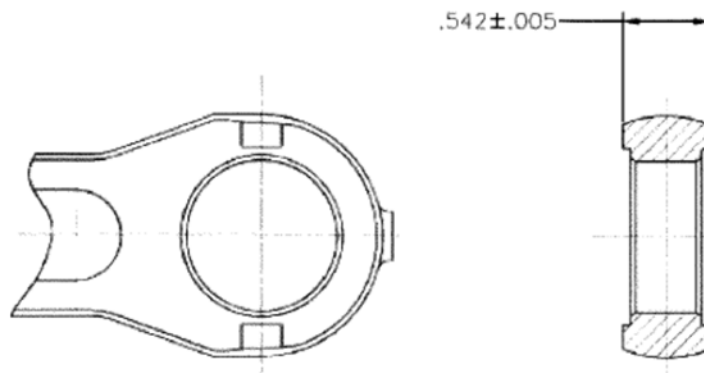
LHT experienced several cases where the anti-rotation lugs of the tailstock show some wear marks. Total Time of most of the Elevator PCUs was below 20,000 FH

1. Perform visual inspection of anti-rotation lugs for scuffing, damage and measure 0.542 ± 0.005
2. Replace tail stock P/N 390643-101 if the above anti rotation lugs dimension is below 0.537 inches.

Following these instructions (basically, Parker provided manufacturing dimension), LHT stated that most of the tailstocks were beyond these limits and had to be replaced. Actual wear exceeds the minimum limit of 0.537 inches by 0.01 inches Parker stated they consider evaluating the possibility of an in-service wear limit, but this will be a "longer term project."

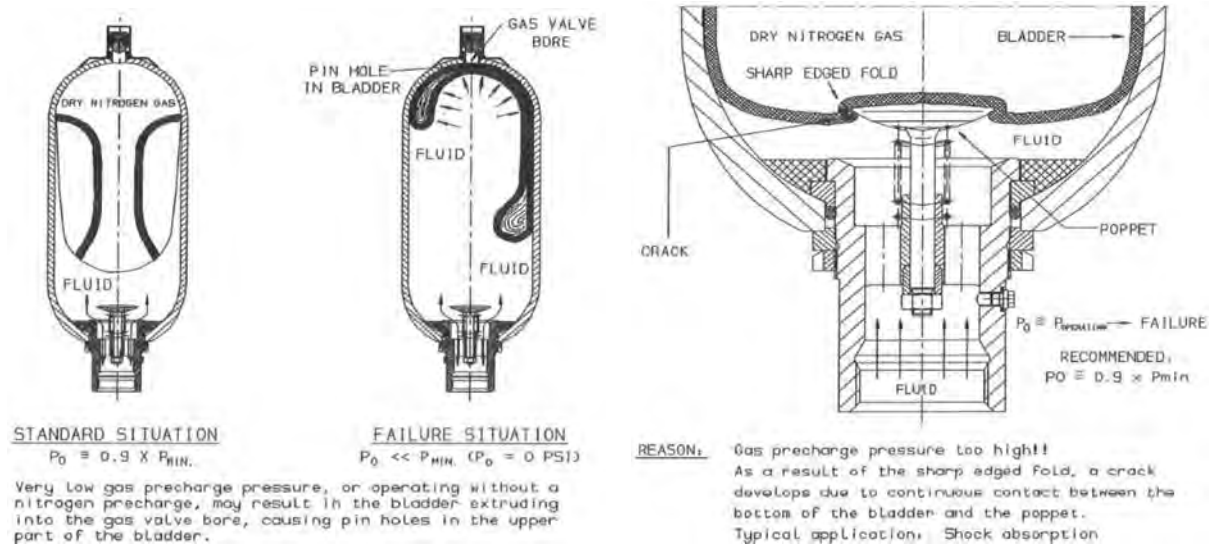
LHT frequently receives hydraulic accumulators from service with damaged bladders. Hydac claims those damages being a result of either under or overfilling situation as shown in the figures below and therefore rejects warranty adjudication, even if the accumulator is with in warranty period. Operators on the other side can prove that all maintenance interval acc. to AMM were met and reject abnormal wear and tear.

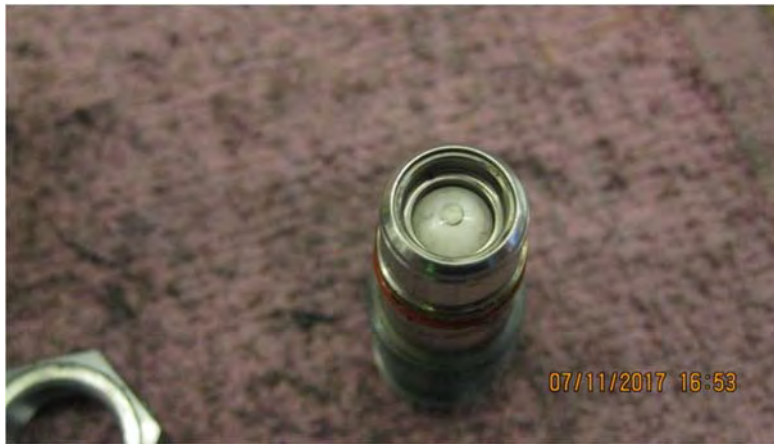
The accumulation of dirt in the valve section of the PCCV Sensor has caused Air Turn Back events for JAL and is the primary cause for one half of removals (excluding NFF) on SR Technics-supported fleets. This failure mode is random in nature and appears to be the result of dirt being released within the engine bleed system. The source is unknown.

Photo showing dirt build-up on the ball-valve of a disassembled PCCV Sensor.

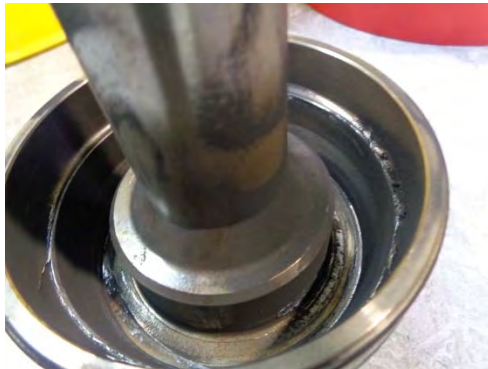
Piston

Examples of damages due to the vibration of engine, caused by the wear of the link on HP regulating valve:

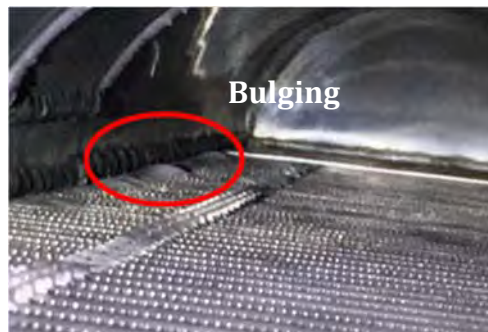
- JAL has experienced many cases of cracking at ram outlet box, V-notch, and closure bar on Heat Exchanger. 18 Heat Exchangers were removed for cracks in 2016 (MTBUR = 15,359 hrs.). Also, we sent the Heat Exchanger to UTAS for cleaning every 12,000 hours for hard-time requirement. Shop findings on the removed units show a high number (over 95%) of crack at ram outlet box and/or closer bar on Heat Exchanger.
- JAL has also experienced a “bulging” at the core thread. If the “bulging” was found at core thread, UTAS replaced the dual core assembly, due to repair procedure not being described in the CMM.

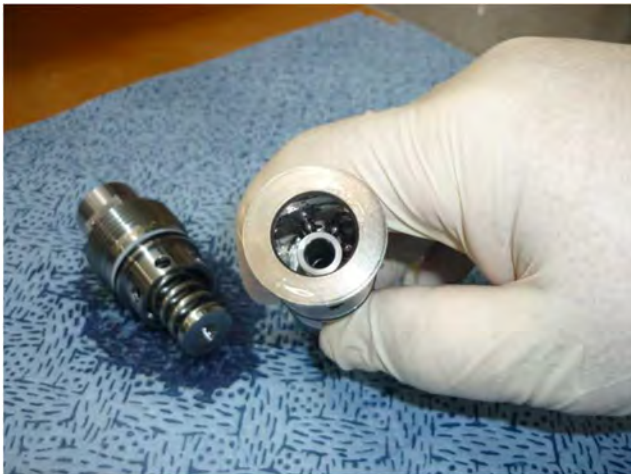
PN TY1540-20 – SN 1855

LHT frequently receives Hydraulic Control Units P/N TY1540-Series and Lower Locking Actuator P/N TY1542 from Engine V2500 with loose balls inside resulting from ball bearing IPL Item 2-280 inside the actuator.

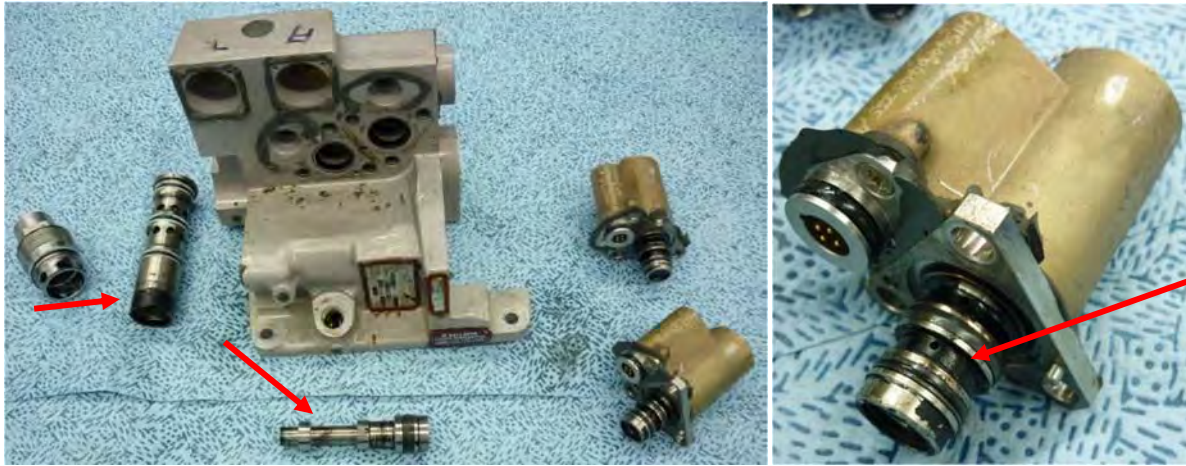
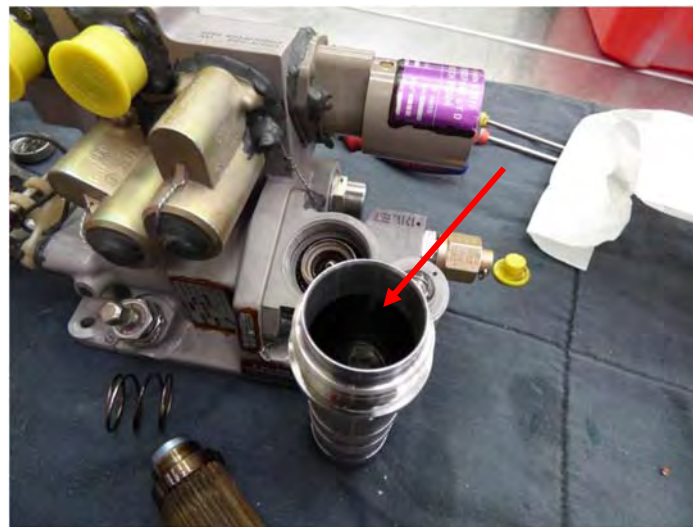
LHT frequently receives Hydraulic Control Units due to overheat situations. Examples are shown on the pictures below. The black oil coal cannot be removed and the units are usually beyond economical repair. In discussion with affected operators and the component OEM, no root cause could be isolated so far.

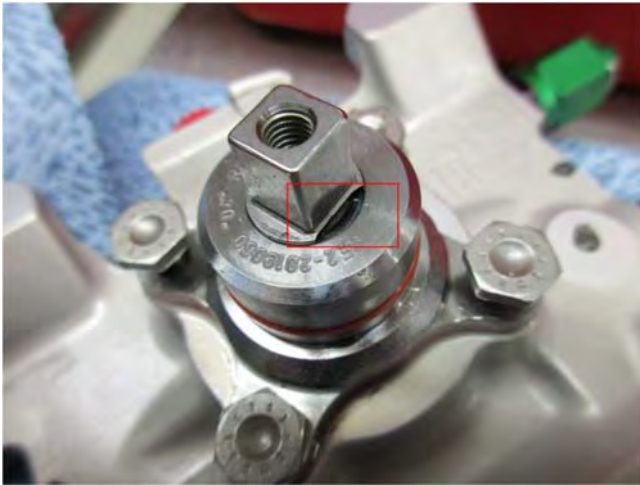
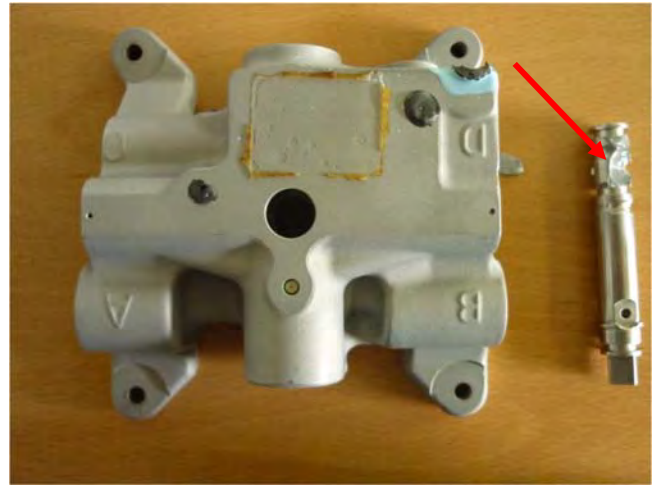
LHT frequently receives units with broken/sheared flange. OEM refers to such cases as mishandling. Operators confirm normal use of manual selector valve handle in service. Until today, only TFU REF: 52.36.00.008 and A/C SB A320-52-1160 are in place, but no component VSB has been issued.

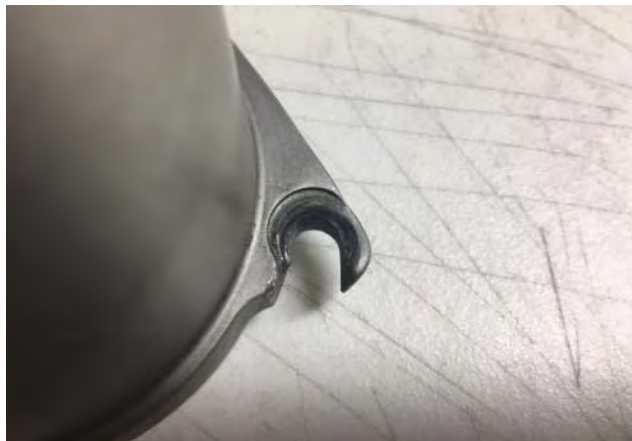
The fuel filter bowl has two lobes with slots (180 degrees apart). These slots engage the attachment studs.

Delta would like Honeywell and Boeing to add specific inspection and rejection criteria for the studs and lobes on the fuel filter bowl in the CMM, AMM and other associated publications.

We would also like Honeywell to develop a repair to restore the damaged area to a parallel surface and add that repair to the CMM.

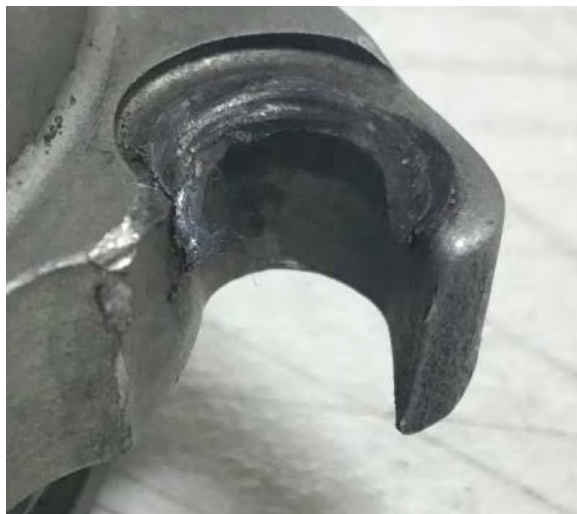
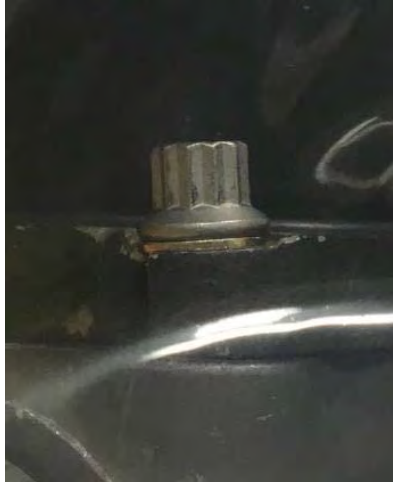
Over time (repeated removal and installation) or with excessive torque, the slot can spread open and the contact surface wear unevenly, causing the attachment stud to pull over and bend when the nut is tightened. There are no specific rejection criteria in the CMM for these conditions. It is subjective to the technician working the part.

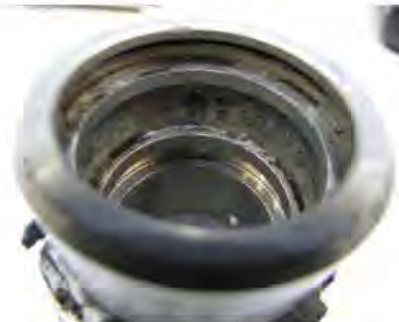
S4-3300955 S/N TP16-188

- Reference CMM 32-31-19-R
 - Incoming test passed; no deviations from specified limits = NFF
 - To enable further investigation the actuator was dismantled with the following main findings:
 - End Gland (Fig 2-180) corroded:

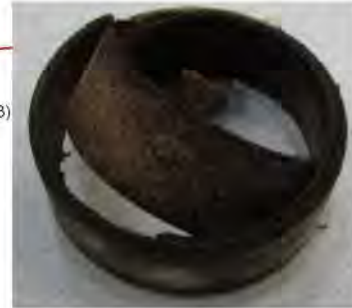
200A	E4-6002190	RING, WEAR GLAND SUPSD BY 200B
-200B	4769-2622-0890	RING, WEAR GLAND (V5F573) OPT TO 9077A0021-01 MADE BY (VD9893) SUPSDS 200A

Note: The wear gland ring 200A was superseded with the introduction of -200B in 2006

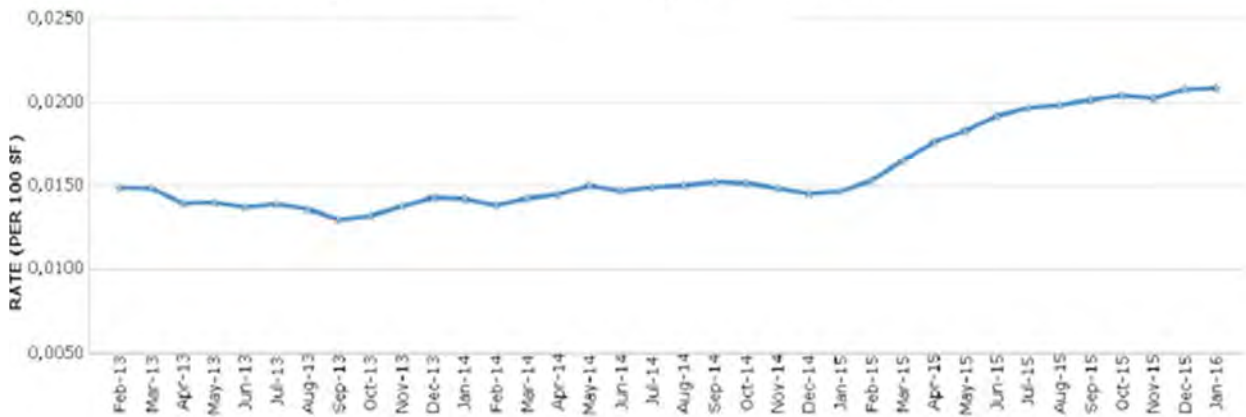
Interruption Rate (SR) - Chargeable - L12M (Ref. Date: 01/2016) - EJETS WORLDWIDE

The chart above from Embraer highlights the increase in EJETS worldwide since February 2013 and the increase in February 2015. Despite the improvements in the NSWCM software, AA and other operators are still experiencing reliability issues.

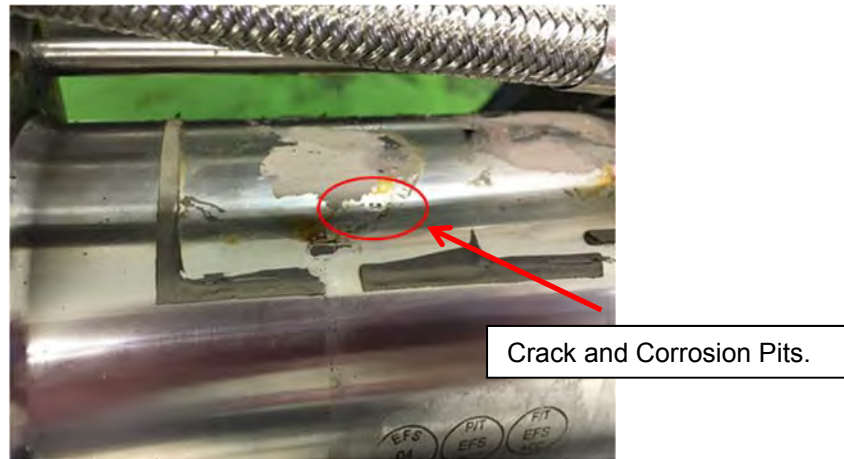
We have experienced several cases of crack on the Cylinder Barrel outer surface under the ID Plate. The crack caused hydraulic fluid leakage and flight dispatch delay/cancel. The cracked Cylinder Barrel was investigated at Boeing, and we had been notified that the root cause of crack was that the cracks were generated as a result of corrosion-related pitting on the outer surface of the Cylinder Barrel. Boeing also informed us that Boeing believes the corrosion pit under the ID plate issues are not a B737NG fleet-wide issue. However, we already experienced six cases of crack on the Cylinder Barrel outer surface under the ID Plate in MLG Retract Actuator Assy, 273A2101-101, since 2015, as below. We would like to know other operator's experience of crack on the Cylinder Barrel outer surface under the ID Plate.

Photo 1: Cylinder Barrel Outer Surface Under the ID Plate (ID Plate Removed)

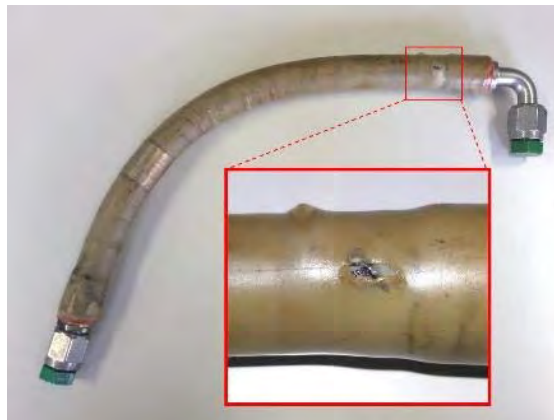
Figure 1 – TITEFLEX Damaged Hose

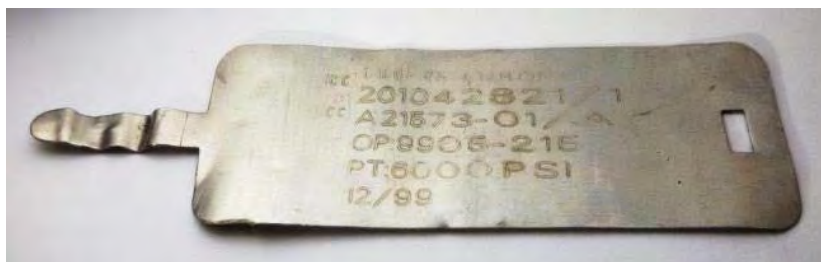
Figure 2 – TITEFLEX Label

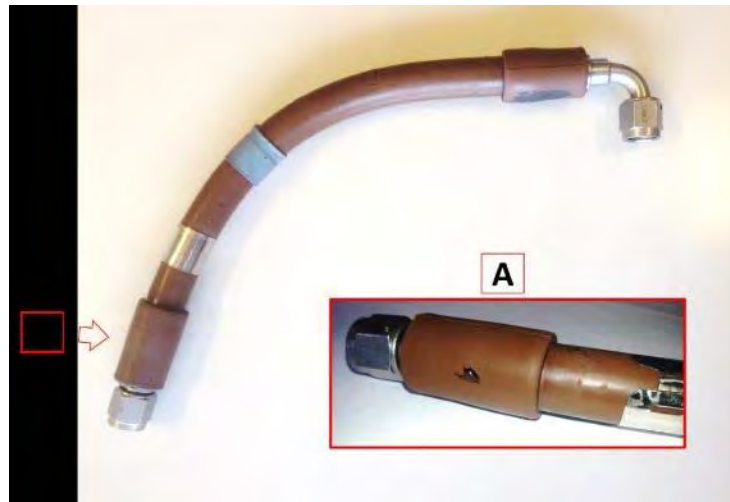
Figure 3 – AEROQUIP Damaged Hose

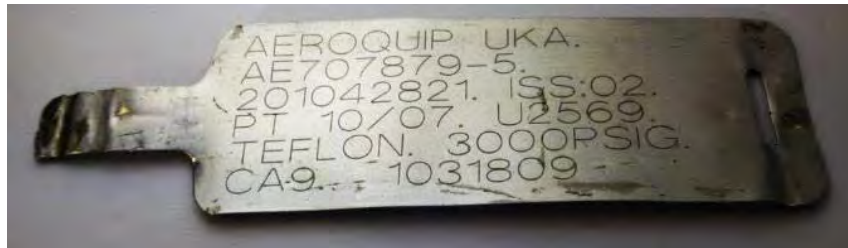
Figure 4 – AEROQUIP Label

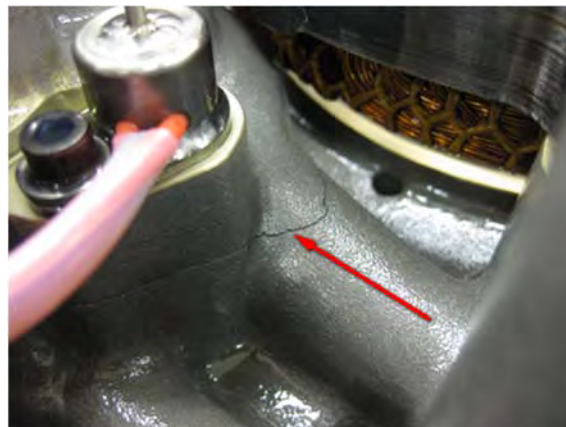
We found several low TSN components with internal leakage because the center housing is cracked (around pump housing).

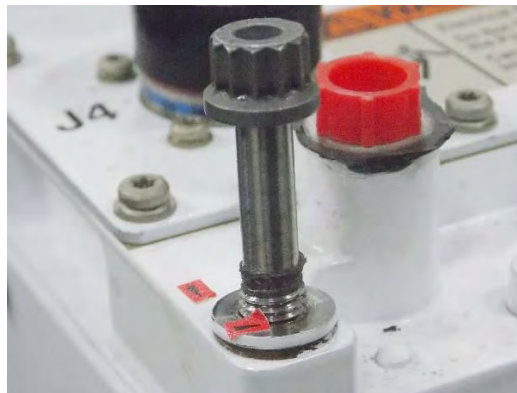
Recently, UTAS has partly denied warranty on an ICS pump assy because one of the bolt-sleeves for a captive bolt was found migrating from the Motor controller chassis. It was noted as 'Customer Induced Damage' (CID), for a simple migrated/damaged sleeve-like insert. Root cause for migrating still unknown.

A CMM repair for these sleeves is not available in the related UTAS CMMs (21-53-92 and 21-54-25). One of the advantages of the G5 pump is the line replaceable Motor Controllers (MC). These MCs are attached by four 'captive bolts' to the Pump chassis. Since these are LRUs, it is very likely that in the future, damage to the bolt sleeves will be seen more often by frequently (re)moving captive bolts during maintenance.
